5.0 Falls City, Texas, Disposal Site

5.1 Compliance Summary

5.3.1 Annual Inspection and Report

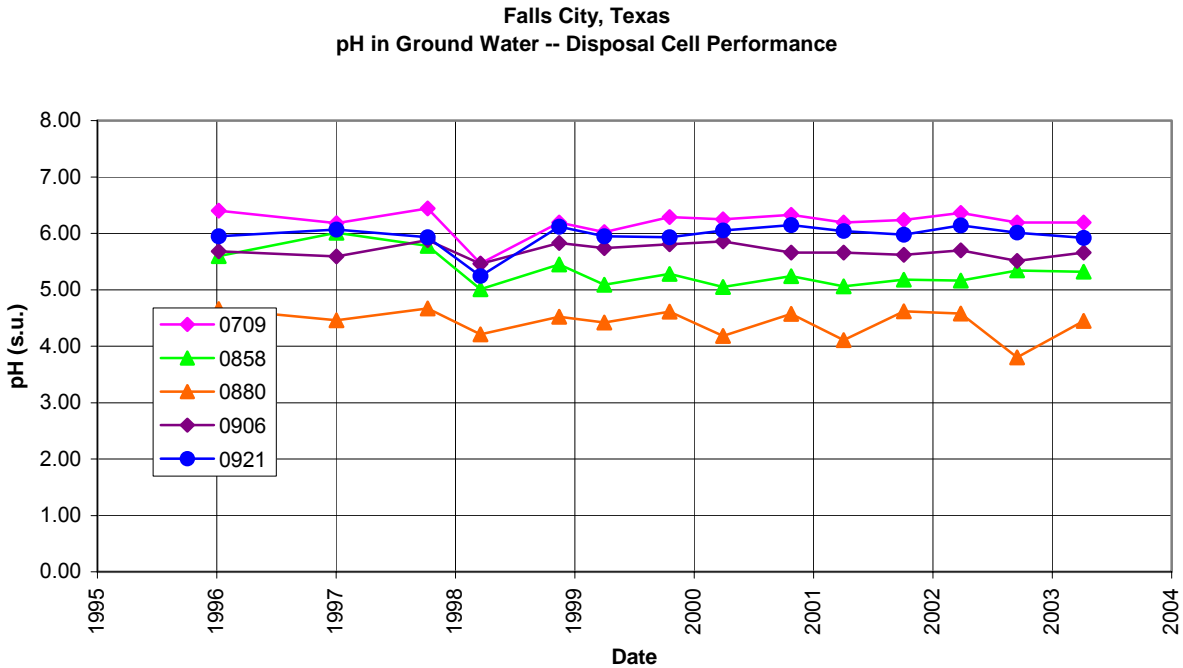
Figure 5-3. pH in Ground Water at Cell Performance Monitoring Locations at the Falls City, Texas, Disposal Site

Analytical results from 2003 generally are consistent with previous results and what would be expected of ground water conditions in a naturally mineralized area that has been impacted by uranium exploration and mining activities. Levels of pH have not varied significantly in recent years (Figures 5-3 and 5-4) and it does not appear that pH is a good indicator for what is occurring with concentrations of uranium or other select constituents in ground water. There is no statistical correlation between changes in pH and changes with the select constituents.

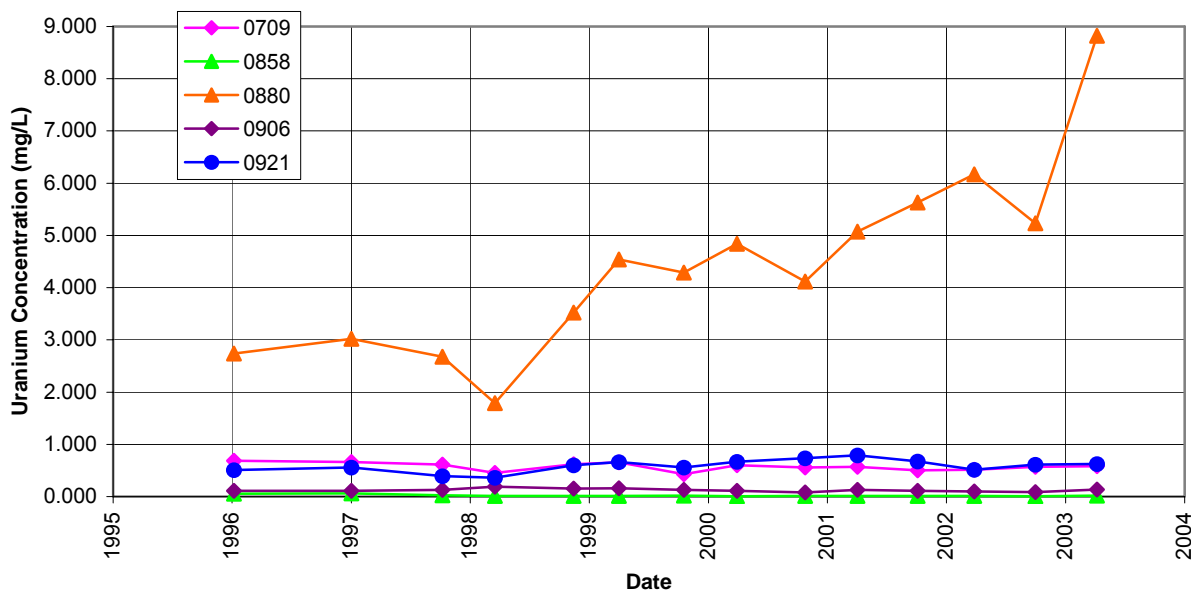
Figure 5-5. Uranium in Ground Water at Cell Performance Monitoring Locations at the Falls City, Texas, Disposal Site

Uranium concentrations in ground water in the vicinity of the disposal cell are consistent with previous results with the exception of monitor well MW-0880, where concentrations continue to increase (Figure 5-5). This increase may be an indication of seepage from the disposal cell, as expected; there is no risk however, because ground water is not used in the area. Uranium in ground water in the compliance monitoring network has varied substantially in two wells (MW-0891 and MW-0924) since 1997 and exceeded the maximum concentration limit of 0.044 mg/L in three wells (MW-0891, 0924, and 0963) in 2003 (Figure 5-6). Concentrations of other analytes in ground water are similar to previous results.

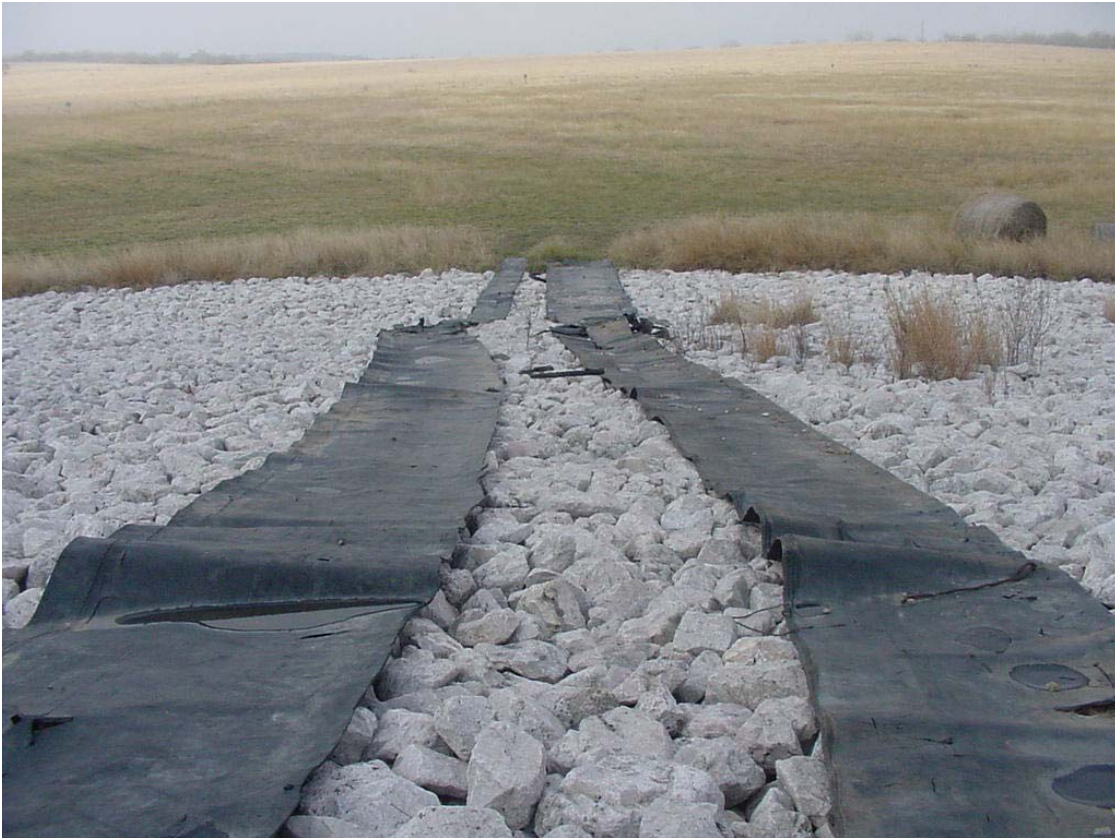
Two tracks of steel-belted rubber conveyor belt material were placed on the west corner of the disposal cell by the hay farmer (PL-1). The conveyor belt material appears to keep the rocks from being overturned as farm equipment is driven up and down the side slope, and does not adversely affect the function of the disposal cell. The material may be left in place as long as it does not fragment into smaller pieces and become distributed as litter.

FCT 1/2003. PL-1. Conveyor belt material placed on the side slope at the west corner of the disposal cell.

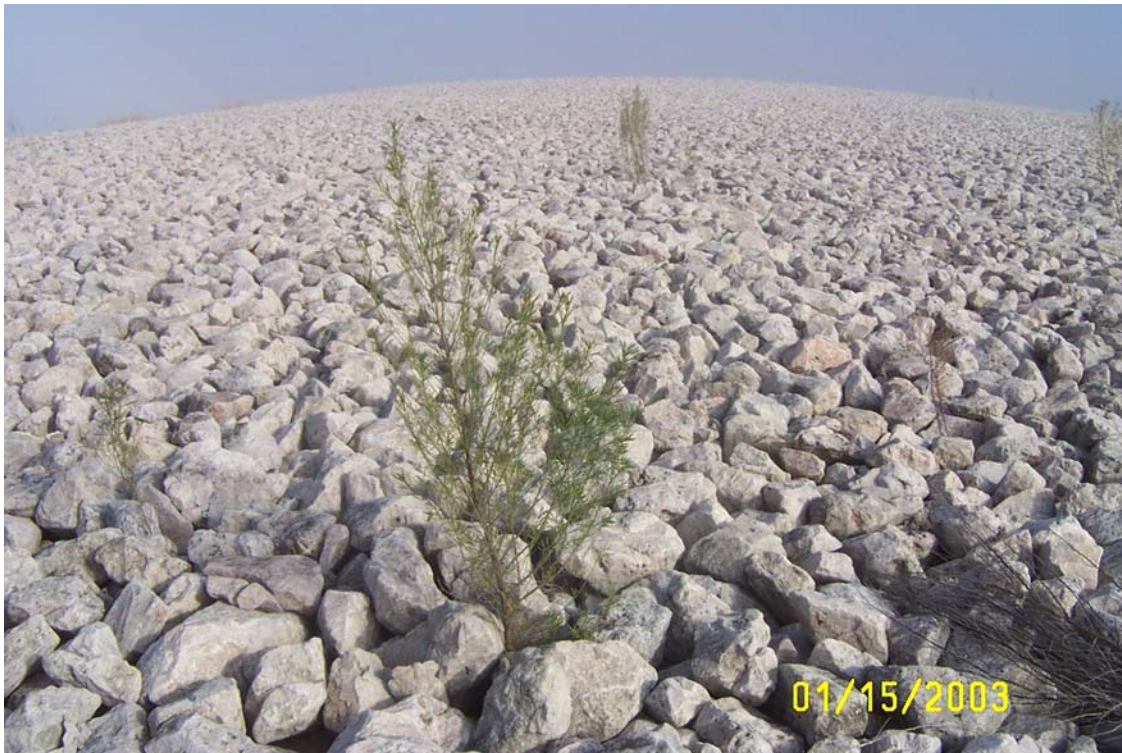
Most vegetation on the side slopes was dead due to herbicide treatment; however, a few woody plant species were found growing along the side slopes (PL-2). Greasewood and similar species are concerns because they are deep-rooted. Vegetation control will continue on the side slopes.

FCT 1/2003. PL-2. Woody plants on the side slope at the south corner of the disposal cell.
